BUILDING MATERIALS AND STRUCTURES

REPORT BMS31

Structural Properties of
"Insulite" Wall and "Insulite"
Partition Constructions
Sponsored by The Insulite Co.

NATIONAL
BUREAU OF STANDARDS

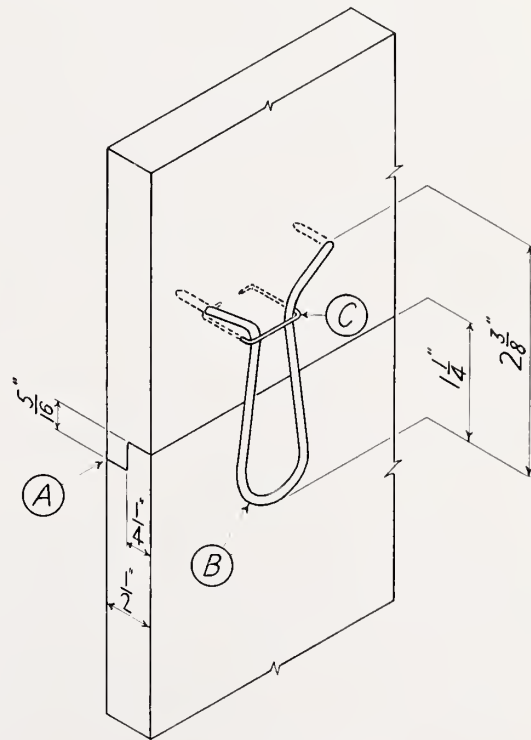
FIGURE 4.—"Lok-Joint" lath.

A, shiplapped joint; B, "Lok" with prongs projecting into the lath; C, staple passing through the lath and clinched.

Rigid insulation board made as described under (a), 1/2 in. thick, 1 ft 6 in. by 4 ft 0 in., shiplapped along each of the longer edges as shown at A, figure 4. There were three "Loks," spaced about 1 ft 4 in. on one shiplapped edge of each lath. The "Lok," B, was a loop of galvanized steel wire, No. 12 (0.1055-in. diam before galvanizing), reinforced by a staple, C, of steel wire No. 19 (0.041-in. diam). The "Loks" were attached to the lath to prevent lateral displacement with respect to the adjacent lath, particularly when the plaster was applied.

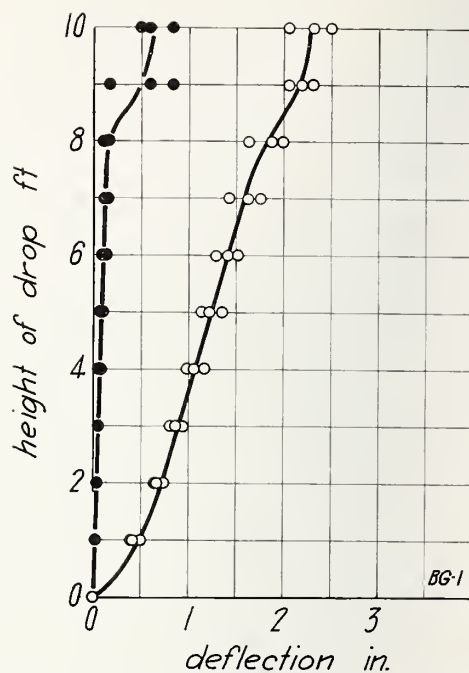
FIGURE 13.—Impact load on wall BG, load applied to inside face.

Height of drop-deflection (open circles) and height of drop-set (solid circles) results for specimens *BG-I1*, *I2*, and *I3* on the span 7 ft 6 in.

The results are shown in table 13 and in figure 13 for wall specimens *BG-I1*, *I2*, and *I3*, loaded on the inside face, and in figure 14 for wall specimens *BG-I4*, *I5*, and *I6*, loaded on the outside face.

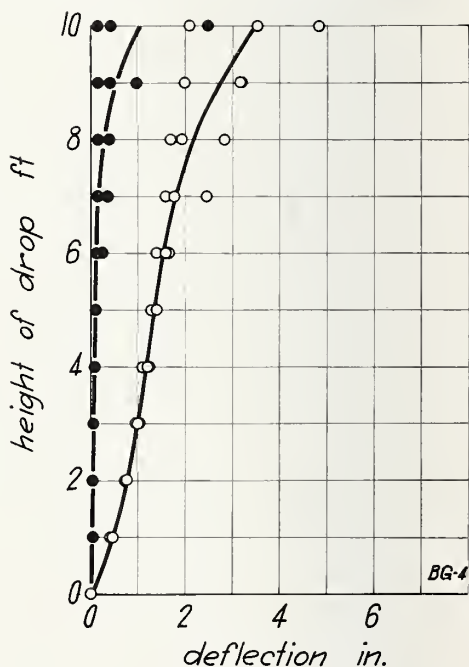
FIGURE 14.—Impact load on wall BG, load applied to outside face.

Height of drop-deflection (open circles) and height of drop-set (solid circles) results for specimens *BG-I4*, *I5*, and *I6* on the span 7 ft 6 in.

The impact loads were applied to the center of the outside face of specimens *I4*, *I5*, and *I6*, the sandbag striking the bevel siding directly over the center stud. In each of the specimens *I4*, *I5*, and *I6* at drops of 2.5, 1, and 1 ft and deflections of 0.85, 0.50, and 0.49 in., respectively, the plaster cracked transversely across each specimen at a lath joint near midspan. At drops of 4, 3, and 3 ft for specimens *I4*,

I5, and *I6*, respectively, the inside face of each specimen failed by further cracking of the plaster. In specimen *I4* the set after a drop of 10 ft was 0.15 in.; several pieces of plaster and lath had fallen from one edge of the specimen, and the lath was separated from both outer studs at midspan, but the outside face and the studs did not fail. In specimen *I5* the center stud broke about 2 ft from midspan at a drop of 6 ft. The set after a drop of 10 ft was 0.41 in.; several pieces of plaster and one section of lath had fallen from the center of the specimen, but the outside face did not fail. In specimen *I6* the center stud broke at midspan at a drop of 8.5 ft, one outer stud broke at midspan at a drop of 9 ft, and the outside face failed at a drop of 9.5 ft by splitting of the siding at midspan. The set after a drop of 10 ft was 2.49 in.; several pieces of plaster and one course of lath had fallen, and the sheathing was ruptured at the center of the specimen.

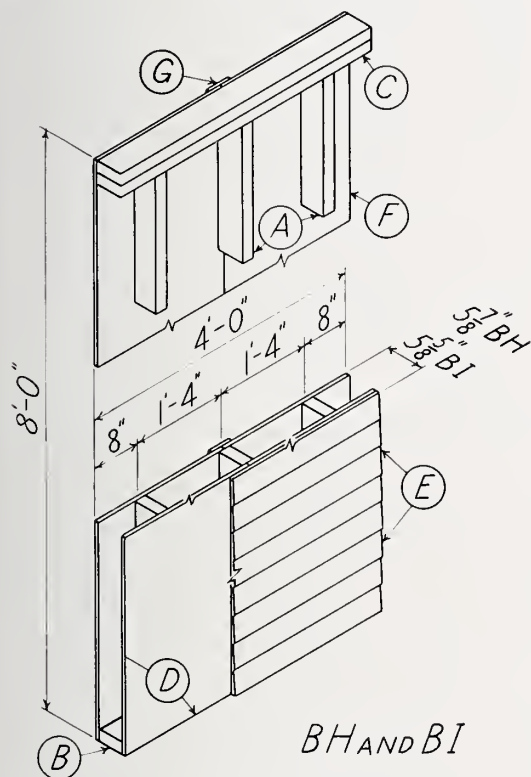
FIGURE 17.—Four-foot wall specimens BH and BI.

A, stud; B, floor plate; C, top plate; D, sheathing; E, bevel siding; F, interior board; G, batten strip.

The 4-ft wall specimens were 8 ft 0 in. high, 4 ft 0 in. wide, and $5\frac{1}{2}$ in. thick. Each specimen consisted of a wood frame to which the faces were fastened. The frame consisted of three studs, *A*, shown in figure 17, fastened to a floor plate, *B*, and a top plate, *C*, by nails. The outside face consisted of insulating-board sheathing, *D*, and wood bevel siding, *E*. The inside face was interior board, *F*, with a vertical joint at midwidth covered by a batten strip, *G*. The specimens were not painted.

Floor plate.—The floor plate, *B*, was red pine, $1\frac{5}{8}$ by $3\frac{3}{8}$ in. (nominal 2 by 4 in.), 4 ft 0 in. long.

Top plate.—The top plate, *C*, consisted of two pieces of red pine, $1\frac{5}{8}$ by $3\frac{3}{8}$ in. (nominal 2 by 4

The 4-ft wall specimens were 8 ft 0 in. high, 4 ft 0 in. wide, and $5\frac{5}{8}$ in. thick. Each specimen consisted of a wood frame to which the faces were fastened. The frame consisted of three studs, A, shown in figure 17, fastened to a floor plate, B, and a top plate, C, by nails. The outside face consisted of insulating-board sheathing, D, and wood bevel siding, E. The

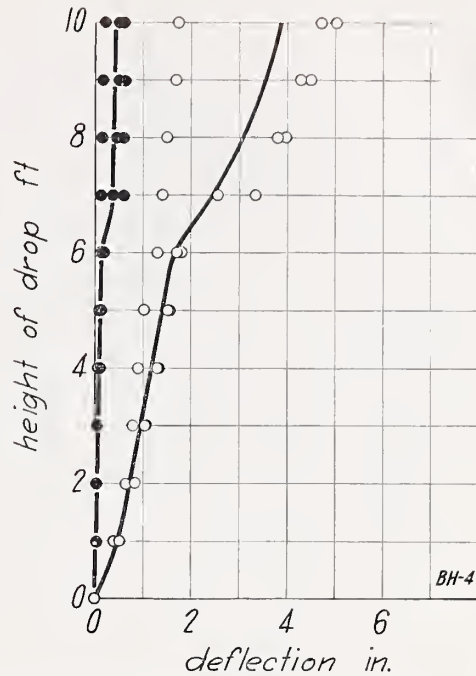
FIGURE 26.—Impact load on wall BH, load applied to outside face.

Height of drop-deflection (open circles) and height of drop-set (solid circles) results for specimens BH-I, *I4*, *I5*, and *I6* on the span 7 ft 6 in.

The results are shown in table 13 and in figure 25 for wall specimens *BH-I1*, *I2*, and *I3*, loaded on the inside face, and in figure 26 for wall specimens *BH-I4*, *I5*, and *I6*, loaded on the outside face.

The impact loads were applied to the center of the outside face of specimens *I4*, *I5*, and *I6*, the sandbag striking the bevel siding directly over the center stud. At drops of 6, 6, and 5 ft for specimens *I4*, *I5*, and *I6*, respectively, the interior board of each specimen started to separate from the outer studs at midspan. In each of the specimens *I4* and *I6* the center stud broke at midspan and the inside face failed

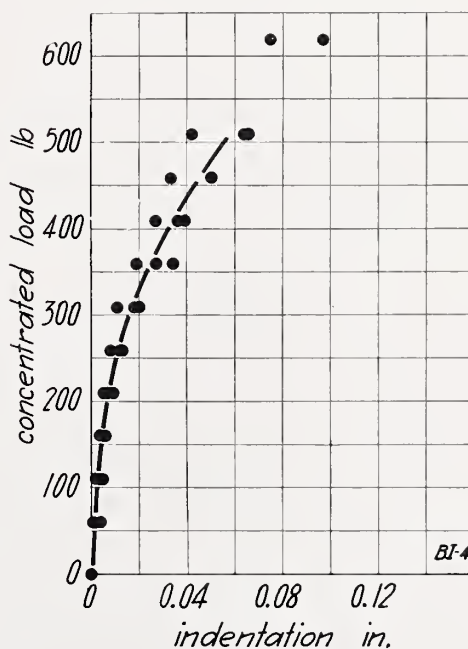
FIGURE 34.—Concentrated load on wall BI, load applied to outside face.

Load indentation results for specimens BI-P4, P5, and P6.

The results are shown in table 13 and in figure 33 for wall specimens BI-P1, P2, and P3, loaded on the inside face, and in figure 34 for wall specimens BI-P4, P5, and P6, loaded on the outside face.

The concentrated loads were applied to the outside face of specimens P4, P5, and P6 on the bevel siding 1½ in. from the edge of a strip of siding midway between two studs and 2½ to

3½ ft from one end. Each of the specimens failed by splitting of the siding for about 8 in. along the grain on opposite edges of the disk.

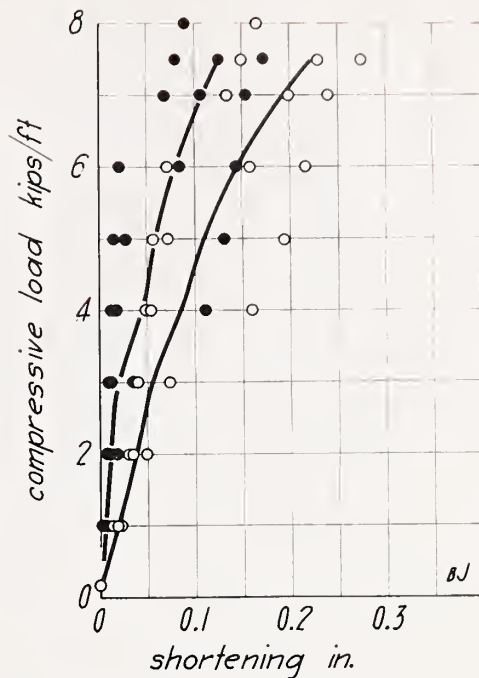
FIGURE 40.—Compressive load on wall *BJ*.

Load-shortening (open circles) and load-set (solid circles) results for specimens *BJ-C1*, *C2*, and *C3*. Load applied one-third the thickness (1.21 in.) from the inside surface of the studs. The loads are in kips per foot of actual width of specimen.

specimens *BJ-C1*, *C2*, and *C3* are shown in table 13 and in figures 40 and 41.

At loads of 6.5, 3.5, and 6 kips/ft on specimens *C1*, *C2*, and *C3*, respectively, the plaster spalled at one end of the specimen. At a load of 7.5 kips/ft on specimen *C3* the stucco cracked transversely across the specimen about 6 in. from the upper end. At the maximum loads specimens *C1* and *C3* failed by crushing of the lower member of the top plate locally at the inside edge of the studs. Specimen *C2* failed by the top plate crushing locally at the inside edge of the studs and separating at the outside edge. In specimen *C2* this rotation pulled the nails from the studs, ruptured the sheathing transversely across the specimen, and allowed the specimen to push out under load without breaking the studs.

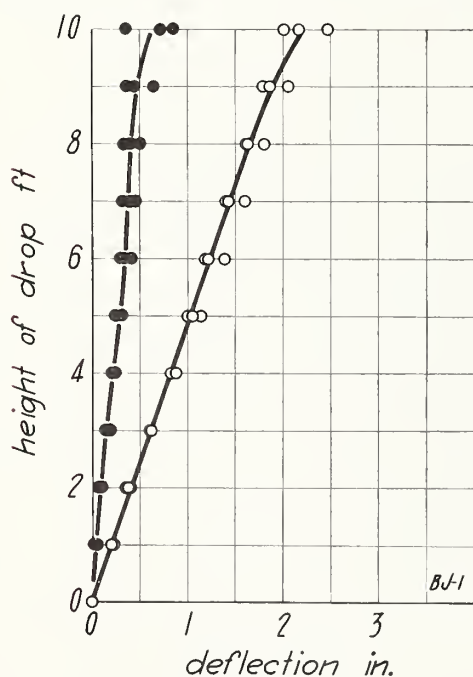
FIGURE 46.—Impact load on wall *BJ*, load applied to inside face.

Height of drop-deflection (open circles) and height of drop-set (solid circles) results for specimens *BJ-I1*, *I2*, and *I3* on the span 7 ft 6 in.

The results are shown in table 13 and in figure 46 for wall specimens *BJ-I1*, *I2*, and *I3*, loaded on the inside face, and in figure 47 for wall specimens *BJ-I4*, *I5*, and *I6*, loaded on the outside face.

The impact loads were applied to the center of the inside face of specimens *I1*, *I2*, and *I3*, the sandbag striking the plaster directly over the center stud. In each of the specimens *I1*, *I2*, and *I3* at drops of 2.5, 2, and 2.5 ft and deflections of 0.49, 0.40, and 0.47 in., respectively, the stucco cracked either along or diagonally across the center stud. At drops of 3, 4.5, and 4 ft, respectively, the inside face of each specimen failed by rupture of the plaster where the sandbag struck. At drops of 4, 8, and 6 ft and deflections of 0.88, 1.61, and 1.22 in., respectively, the stucco cracked transversely across each specimen near midspan. In specimens *I1* and *I3* at a drop of 8 ft the outside face of each specimen failed by opening of the cracks in the stucco. In specimen *I1* the center stud broke at midspan at a drop of 9.5 ft. The sets after

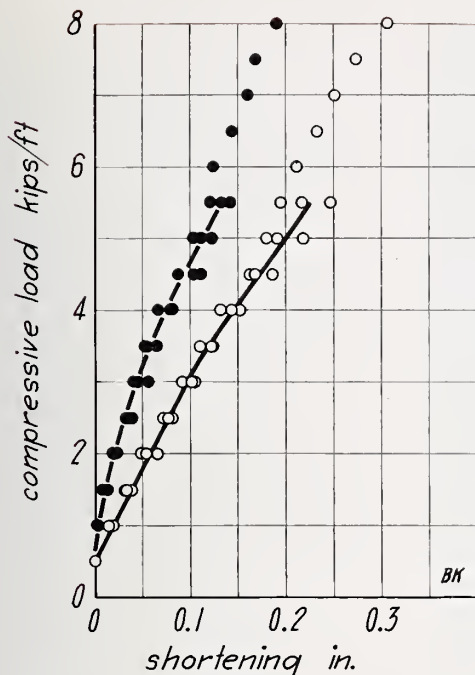
FIGURE 50.—Compressive load on wall BK.

Load-shortening (open circles) and load-set (solid circles) results for specimens BK-C1, C2, and C3. Load applied to the wood frame only, one-third the thickness (1.21 in.) from the inside surface of the studs. The loads are in kips per foot of actual width of specimen.

The results for wall specimens *BK-C1*, *C2*, and *C3* are shown in table 13 and in figures 50 and 51.

Each of the specimens failed by the top plate crushing locally at the inside edge of the studs and separating at the outside edge. This rotation of the top plate pulled the nails from the studs, ruptured the sheathing transversely across most of the width of the specimen, and either ruptured the lath or separated it from the upper ends of the studs. No failure of the brick veneer was observed.

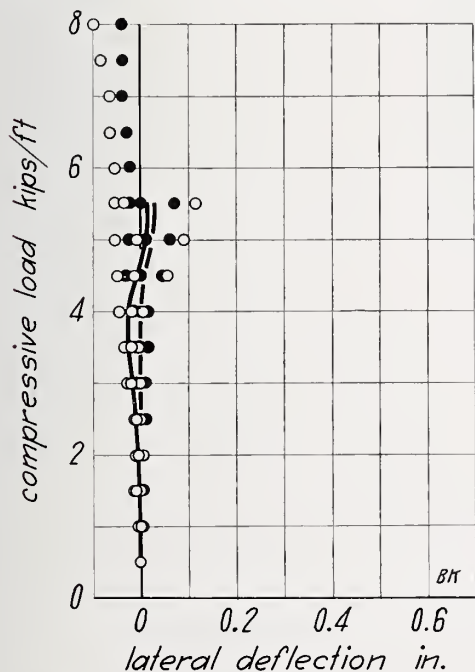
FIGURE 51.—Compressive load on wall BK.

Load-lateral deflection (open circles) and load-lateral set (solid circles) results for specimens BK-C1, C2, and C3. Load applied to the wood frame only, one-third the thickness (1.21 in.) from the inside surface of the studs. The loads are in kips per foot of actual width of specimen.

The upper loading plate was not in contact with the brick veneer. The lateral deflections shown in figure 51 are plotted to the right of the vertical axis for deflections of the specimens toward the outside face and to the left for deflections toward the inside face. Specimens *C1* and *C3* deflected toward the inside face for all loads up to and including the maximum load. Specimen *C2* deflected toward the outside face for almost all loads. The lateral deflections of specimens *C1* and *C3* toward the inside face were probably due either to the stiffness of the inside face counteracting the effect of the eccentric loads or to the little resistance afforded by the brick veneer to deflection in this direction.

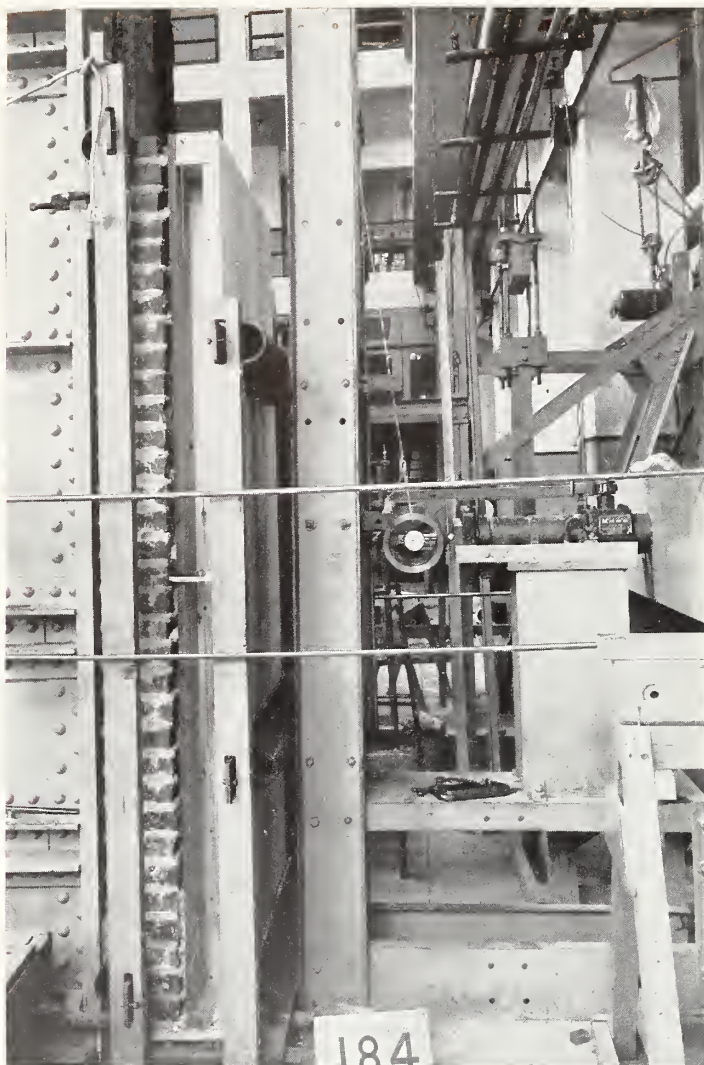
FIGURE 52.—Wall specimen *BK-T3*, under transverse load.

Wall specimen BK-T3 under transverse load is shown in figure 52. The results are shown in table 13 and in figure 53 for wall specimens BK-T1, T2, and T3, loaded on the inside (plastered) face, and in figure 54 for wall specimens BK-T4, T5, and T6, loaded on the outside (brick-veneer) face.

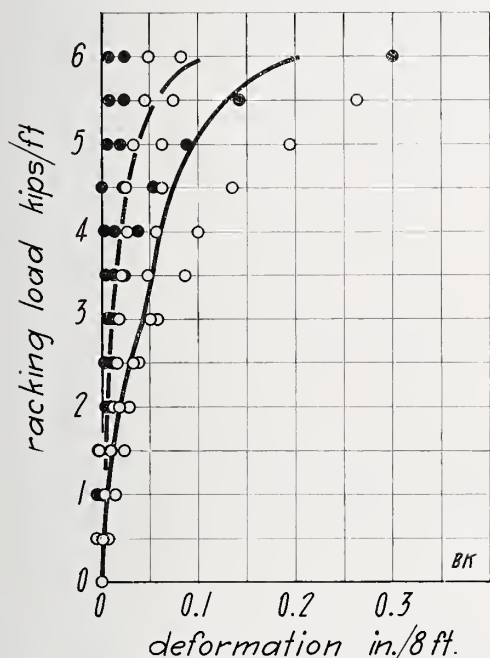
FIGURE 59.—Racking load on wall *BK*.

Load-deformation (open circles) and load-set (solid circles) results for specimens *BK-R1*, *R2*, and *R3*. The loads are in kips per foot of the face width of specimen (8 ft 0 in).

The results for wall specimens *BK-R1*, *R2*, and *R3* are shown in table 13 and in figure 59.

tionally in several places, approximately parallel to a diagonal from the point of application of load to the stop. There was also noticeable vertical displacement between the sheathing boards at the joint. During the application of the next increment of load the wood frame deformed so much more than the brick veneer that the ring dynamometer slipped out of the frame. The ring dynamometer was then centered 2.5 in. from the outside face, a load of 6.25 kips/ft was applied, and no further effect was observed.

Specimen *R2* failed by rupture of the brick veneer in a stepwise crack approximately along a diagonal from the point of application of load to the stop. The crack usually followed the bed and head joints but went through the brick in a few places. No other failure of the specimen was observed. In specimen *R3* the set after a load of 6.25 kips/ft had been applied was 0.026 in./8 ft, and no further effect was observed.

tions and sets shown in figure 59 for a height of 8 ft were computed from the values obtained from the measuring-device readings. The gage length of the vertical measuring device was 6 ft 9 in. The gage length of the horizontal measuring device was 5 ft. The deformations and sets are the averages of the deformations and sets for the wood frame and for the brick veneer measured independently by two sets of deformation-measuring devices.

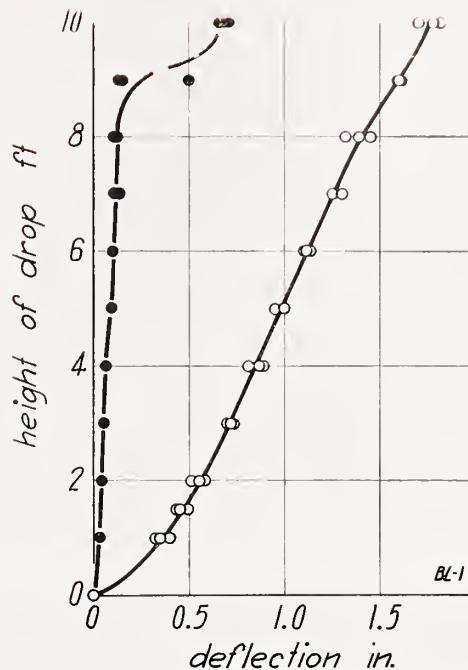
FIGURE 67.—Impact load on wall BL, load applied to inside face.

Height of drop-deflection (open circles) and height of drop-set (solid circles) results for specimens BL-11, 12, and 13 on the span 7 ft 6 in.

The results are shown in table 13 and in figure 67 for wall specimens BL-11, 12, and 13, loaded on the inside face, and in figure 68 for wall specimens BL-14, 15, and 16, loaded on the outside face.

The impact loads were applied to the center of the inside face of specimens 11, 12, and 13, the sandbag striking the plaster directly over the center stud. In each of the specimens 11, 12, and 13 the plaster cracked longitudinally over either one or both outer studs at a drop of 1 ft, and at drops of 2.5, 3, and 2.5, respectively, the inside face of each specimen failed by sagging of the overhanging plaster edges. At drops of 3.5, 2, and 3 ft and deflections of

0.79, 0.69, and 0.72 in. in specimens *I1*, *I2*, and *I3*, respectively, the plaster cracked transversely across each specimen at a lath joint near midspan. The sets after a drop of 10 ft were 0.66, 0.71, and 0.68 in. in specimens *I1*, *I2*, and *I3*, respectively. Some of the furring strips were separated from the sheathing near midspan, but the outside face and the studs did not fail.

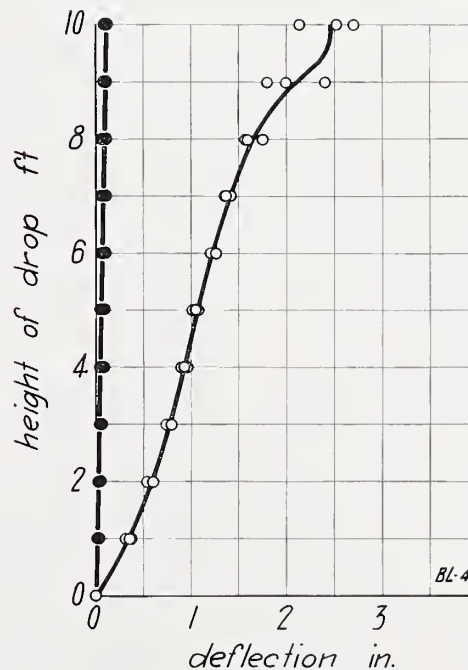
FIGURE 68.—Impact load on wall BL, load applied to outside face.

Height of drop-deflection (open circles) and height of drop-set (solid circles) results for specimens BL-14, 15, and 16 on the span 7 ft 6 in.

The impact loads were applied to the center of the outside face of specimens *I4*, *I5*, and *I6*, the sandbag striking the shingles directly over the center stud. In each of the specimens the plaster cracked transversely across each specimen at several places. The first cracks occurred at lath joints near midspan at drops of 3, 2.5, and 2.5 ft and deflections of 0.79, 0.69, and 0.65 in. in specimens *I4*, *I5*, and *I6*, re-

spectively. At drops of 4, 4.5, and 4 ft, respectively, the inside (plastered) face of each specimen failed by opening of the cracks in the plaster. The sets after a drop of 10 ft were 0.12, 0.08, and 0.08 in. in specimens *I4*, *I5*, and *I6*, respectively. Most of the plaster had fallen, but the outside face and studs were undamaged.

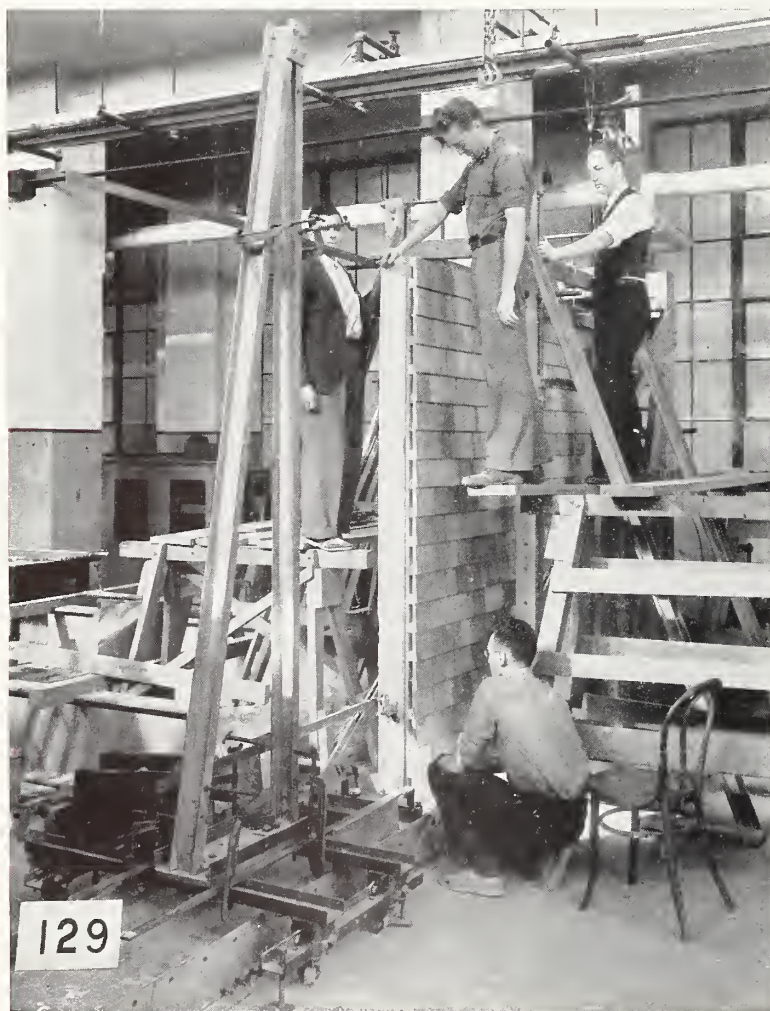
FIGURE 69.—Wall specimen *BL-R1* under racking load.

Wall specimen *BL-R1* under racking load is shown in figure 69. The results for wall specimens *BL-R1*, *R2*, and *R3* are shown in table 13 and in figure 70.

The racking loads were applied to the top plate only and the stop was in contact with the floor plate only. In each of the specimens the plaster cracked in several places. Most of the

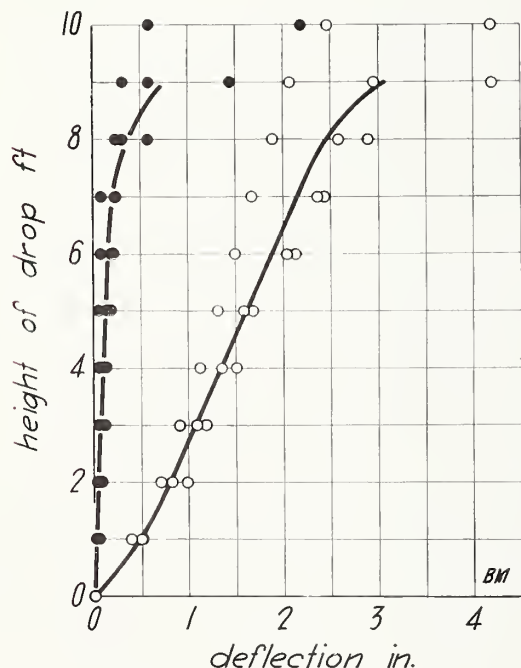
FIGURE 72.—Impact load on partition *BM*.

Height of drop-deflection (open circles) and height of drop-set (solid circles) results for specimens *BM-I1*, *I2*, and *I3* on the span 7 ft 6 in.

The results for partition specimens *BM-I1*, *I2*, and *I3* are shown in table 14 and in figure 72.

The impact loads were applied to the center of one face of each specimen, the sandbag striking the plaster directly over the center stud. In each of the specimens the plaster on both faces cracked longitudinally along the studs and transversely across each specimen in several places. The first transverse cracks in the face opposite the face struck occurred at lath joints near midspan at drops of 2, 1, and 1.5 ft and deflections of 0.70, 0.50, and 0.70 in. in specimens *I1*, *I2*, and *I3*, respectively. The first transverse cracks in the face struck occurred at lath joints near midspan at a drop of 3 ft and deflections of 0.90, 1.08, and 1.18 in. in specimens *I1*, *I2*, and *I3*, respectively. At drops of 4, 5, and 4.5 ft, on specimens *I1*, *I2*, and *I3*, respectively, the face struck by the sandbag failed owing to rupture of the plaster at midspan, especially at the point of impact. At drops of 5.5, 6.5, and 6 ft on specimens *I1*, *I2*, and *I3*, respectively, the face opposite that struck by the sandbag failed by falling of some of the plaster. In each of the specimens the center stud broke at midspan at drops of 10, 9, and 10 ft, respectively. Specimen *I2* failed structurally at a drop of 10 ft by the sandbag passing through the specimen.

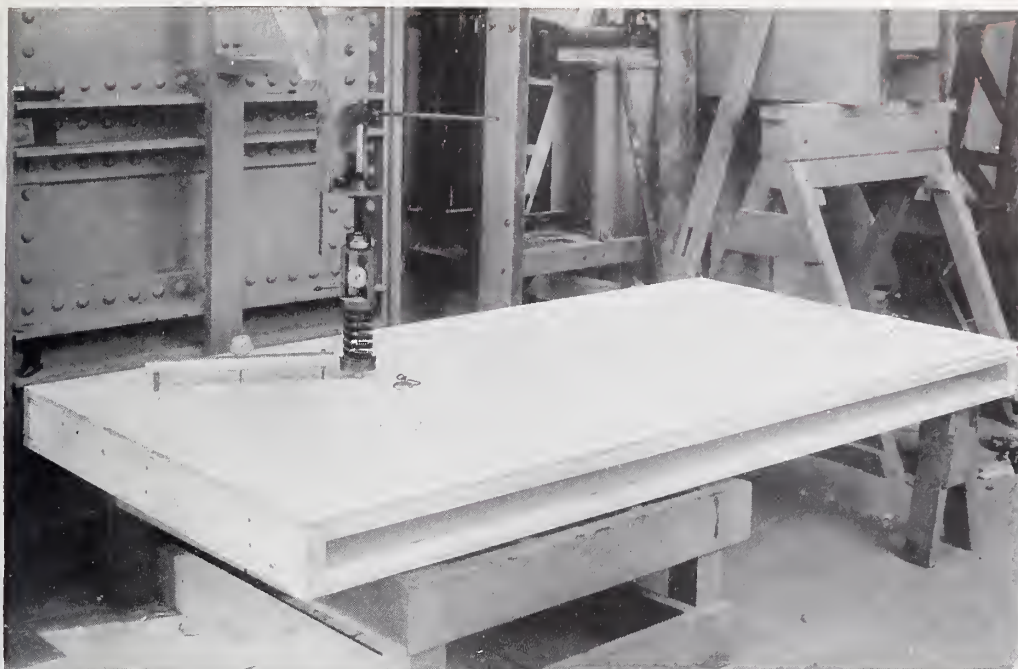
FIGURE 73.—Partition specimen *BM-P2* under concentrated load.

Partition specimen *BM-P2* under concentrated load is shown in figure 73. The results for partition specimens *BM-P1*, *P2*, and *P3* are shown in table 14 and in figure 74.

The concentrated loads were applied to one face of each specimen on the plaster midway between two studs over a lath joint $1\frac{1}{2}$ to 2 ft from one end of the specimen. Each of the

specimens failed by punching of the disk through the plaster and by the spreading of the lath at the joint.

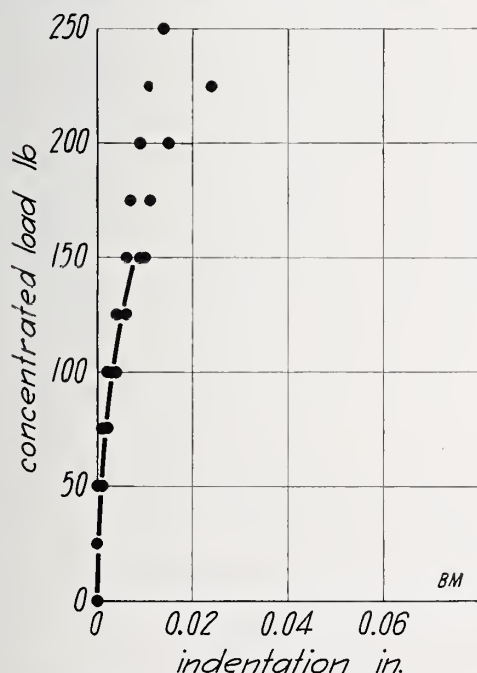
FIGURE 74.—Concentrated load on partition *BM*.
Load-indentation results for specimens *BM-P1*, *P2*, and *P3*.

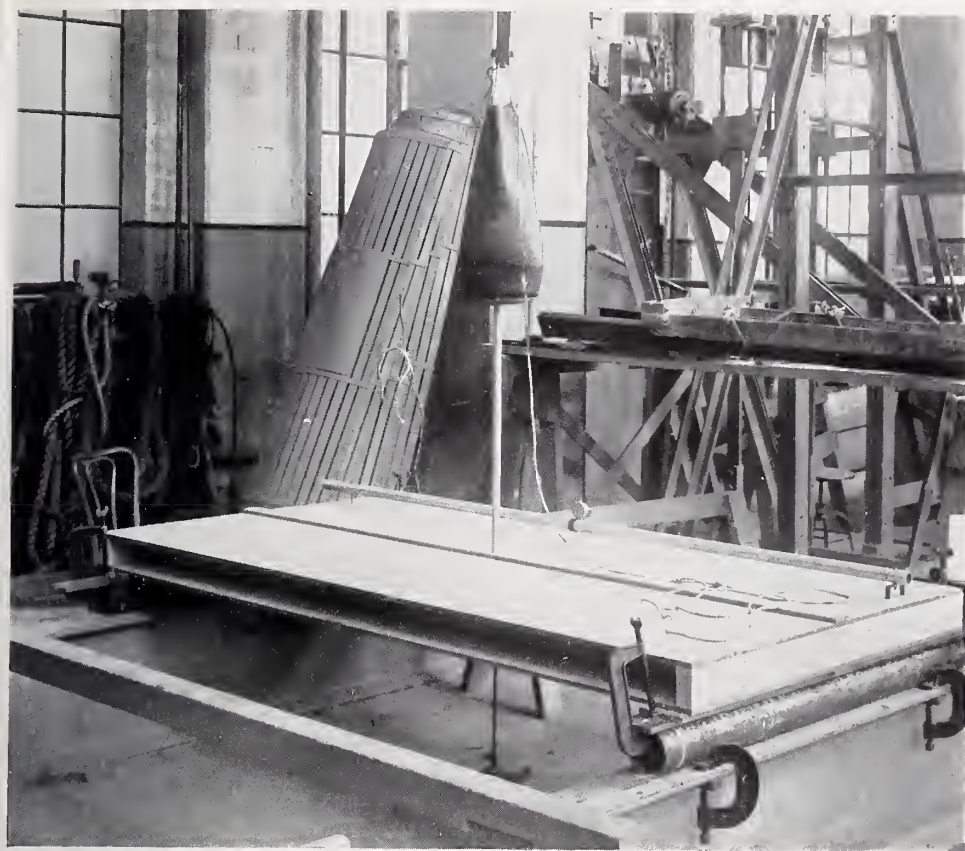
FIGURE 76.—Partition specimen BN-12 during the impact test.

Partition specimen *BN-I2*, during the impact test, is shown in figure 76. The results for partition specimens *BN-I1*, *I2*, and *I3* are shown in table 14 and in figure 77.

The impact loads were applied to the center of one face of each specimen, the sandbag striking the batten strip and the interior board directly over the center stud. In each of the specimens the interior board on the face opposite the face struck separated from the studs at drops of 4, 7, and 6 ft on specimens *I1*, *I2*, and *I3*, respectively, and these faces failed by rupture of the interior board at midspan transversely across each specimen at drops of 4.5, 8, and 6 ft, respectively. At drops of 4.5, 8, and 3.5 ft, respectively, the face struck failed by rupture of the interior board where the sandbag struck. At drops of 4.5, 7.5, and 6 ft, respectively, the center stud of each specimen ruptured at midspan. At the maximum height of drop, each specimen failed by the sandbag passing through the specimen.

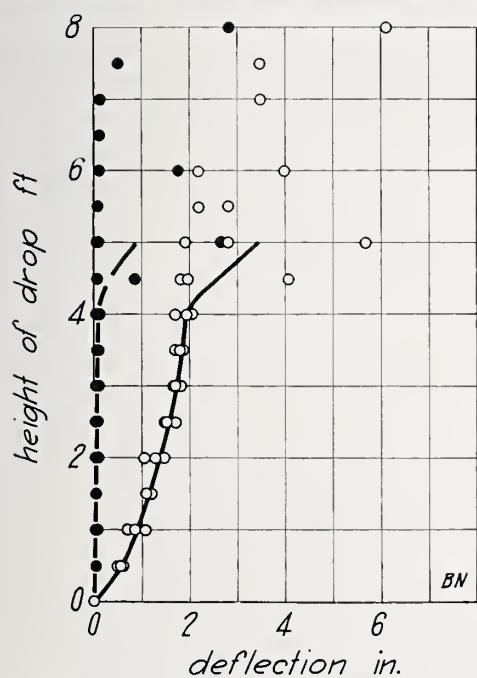
FIGURE 77.—Impact load on partition BN.

Height of drop-deflection (open circles) and height of drop-set (solid circles) results for specimens BN-11, 12, and 13 on the span 7 ft 6 in.

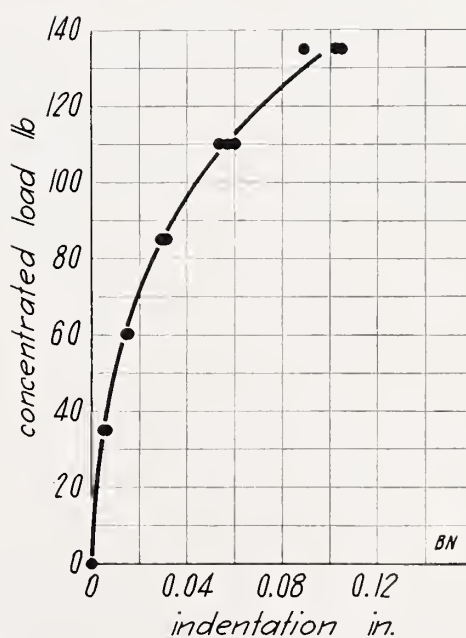
FIGURE 78.—Concentrated load on partition BN.

Load-indentation results for specimens BN-P1, P2, and P3.

The results for partition specimens *BN-P1*, *P2*, and *P3* are shown in table 14 and in figure 78.

The concentrated loads were applied to one face of each specimen on the interior board midway between two studs and about $1\frac{1}{2}$ ft from one end of the specimen. Each of the specimens failed by punching of the disk through the interior board.
